Boston's Open Space

1987
PARK EVALUATION
&
SITE SUMMARIES

EVALUATION OF
CITY OF BOSTON
PARK AND RECREATION LAND

NEIGHBORHOOD OF HYDE PARK

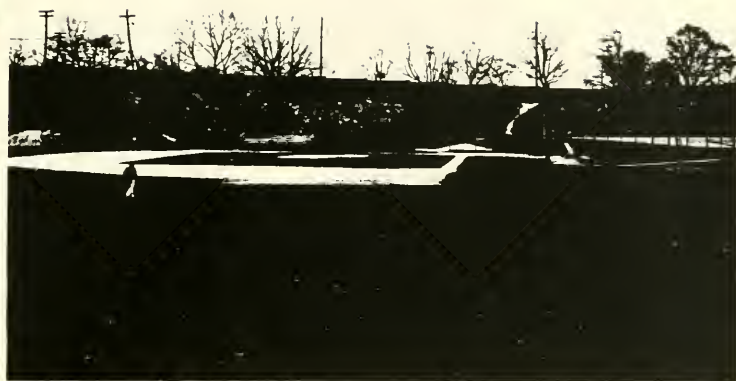
Site Photograph 1

Baseball field - grass and infield well maintained.

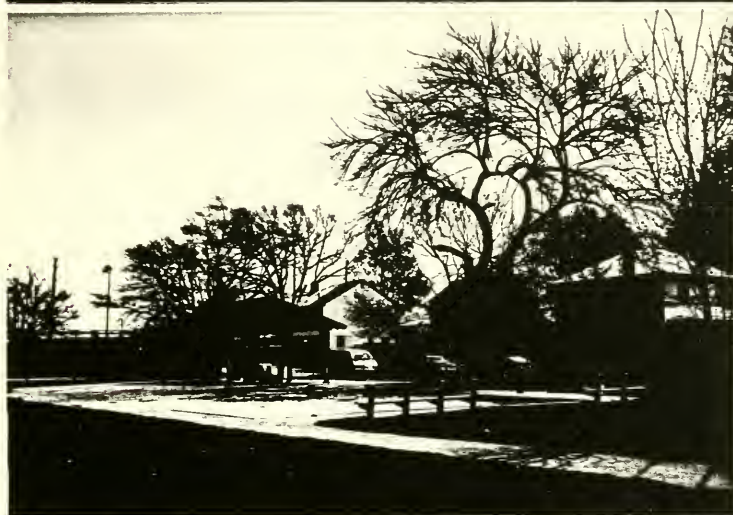
Site Photograph 5

Playground - No equipment other than swings.

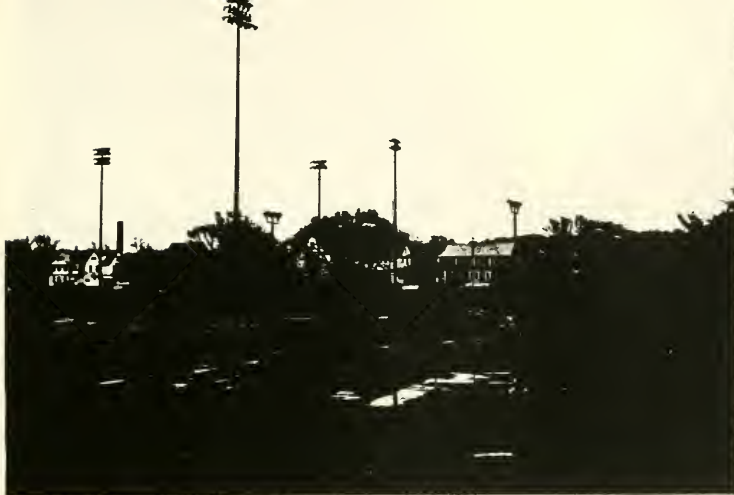
Site Photograph 4

Site of proposed new courts.

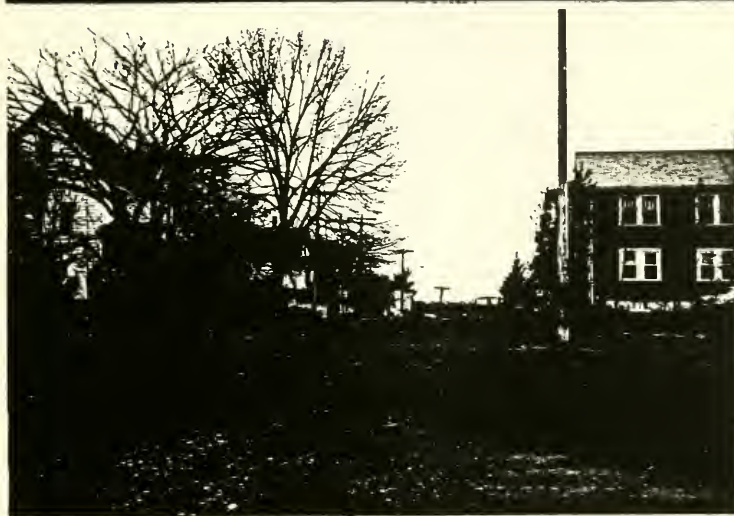
Site Photograph 5

Access from Rosa Street.

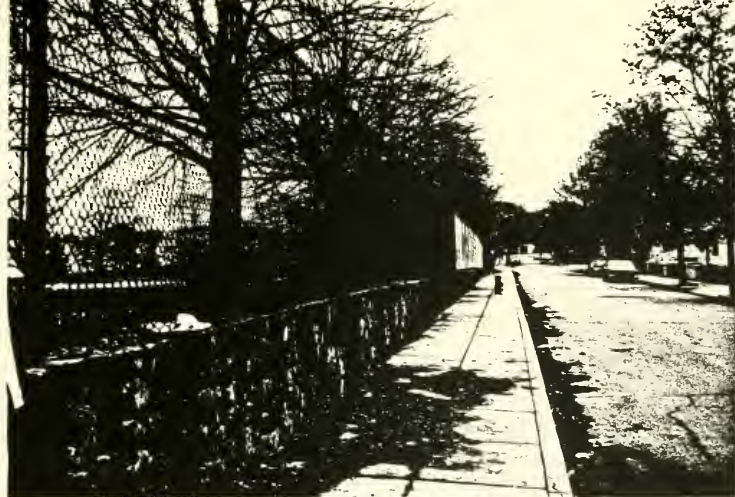
Site Photograph 7

Well-built stone wall
with chain link fence.

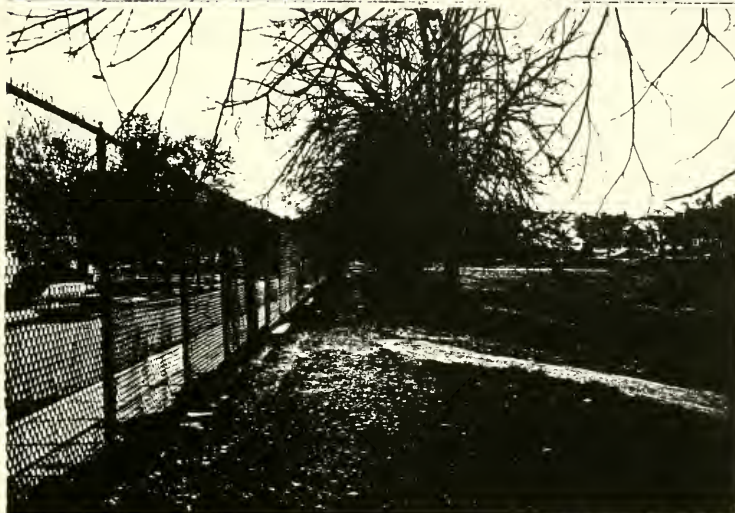
Site Photograph 8

Perimeter planting of
Lindens a significant
feature of site. Old
asphalt walkway to
left of trees.

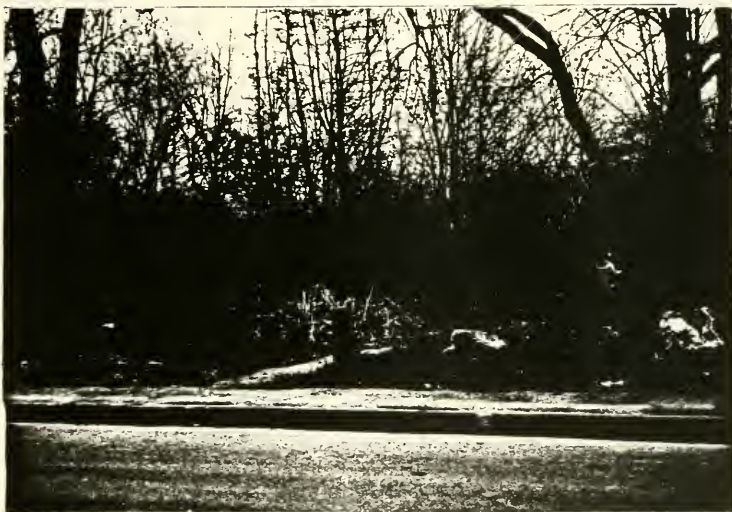
Site Photograph 1

Entrance to park with
urban wild to right.

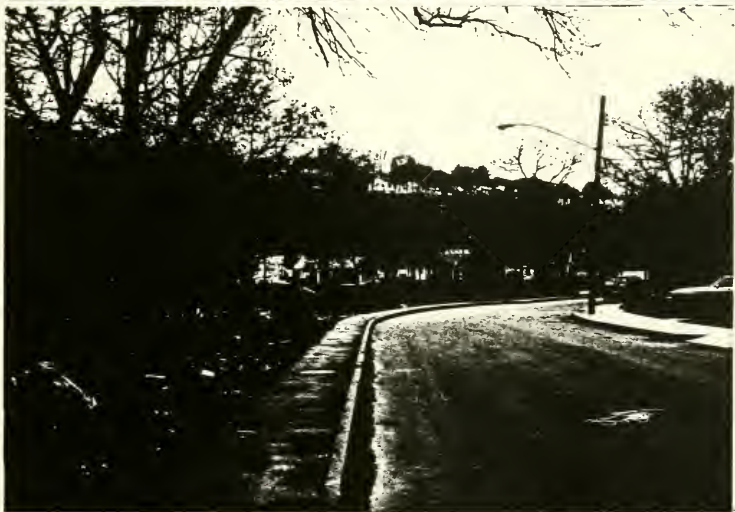
Site Photograph 2

Shows location of
park within residential
neighborhood.

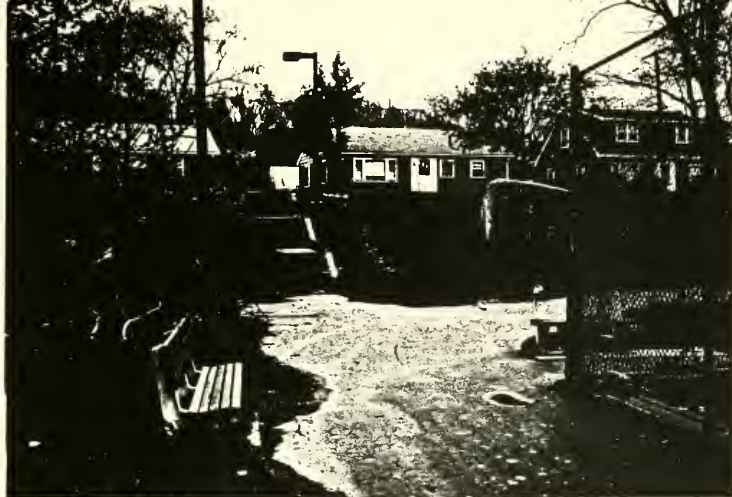
Site Photograph 4

Timber steps up to Sherrin Street. Urban wild to left.

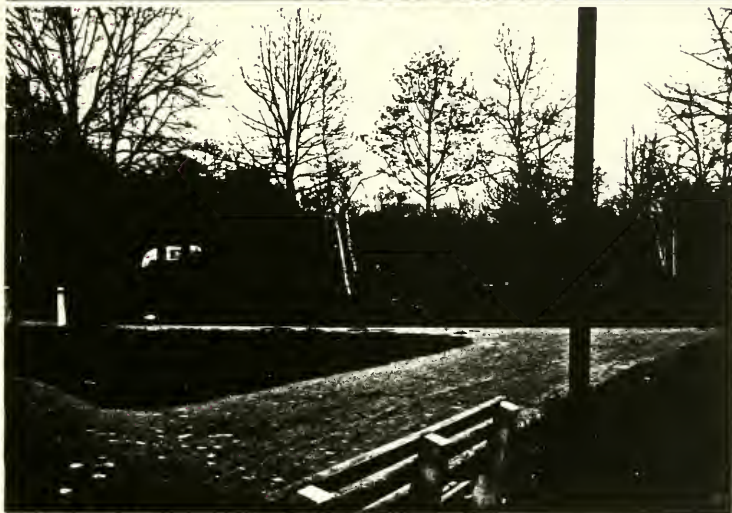
Site Photograph 5

View into picnic/play area showing original and planted trees.

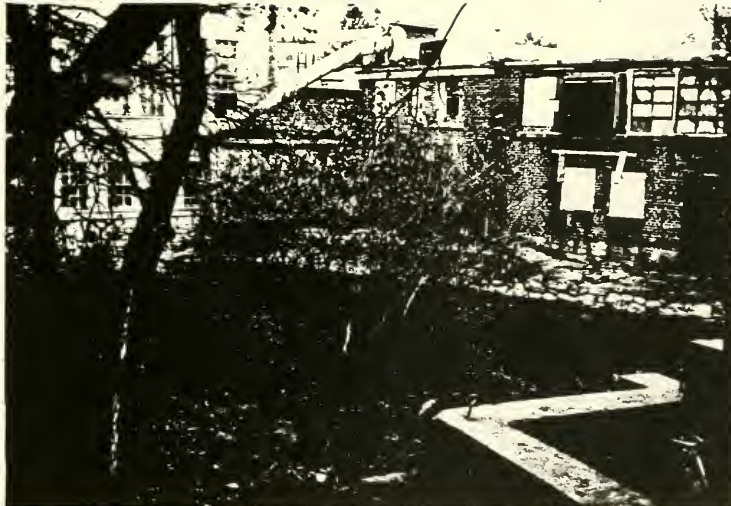
Site Photograph 1

Industrial view from
edge of Mother Brook.

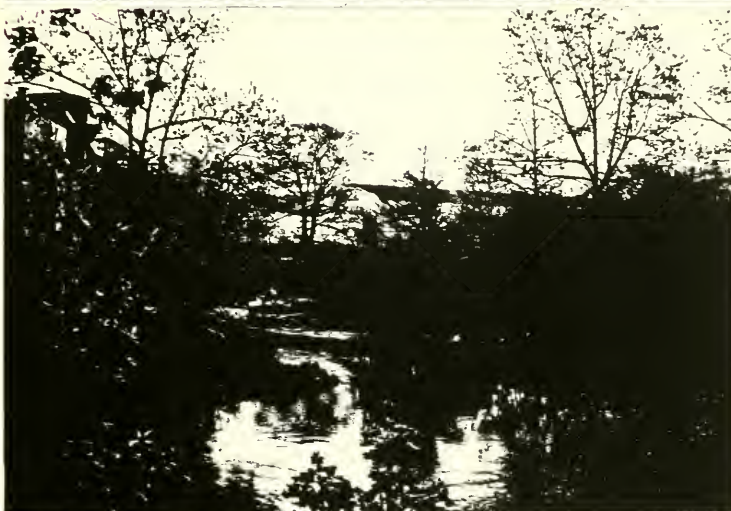
Site Photograph 2

Scenic view of bend
in the river.

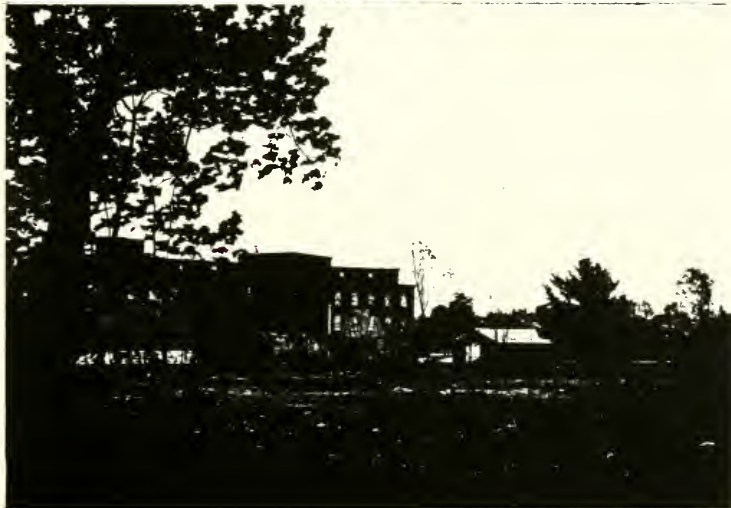
Site Photograph 3

View looking east
from site towards
railroad tracks.

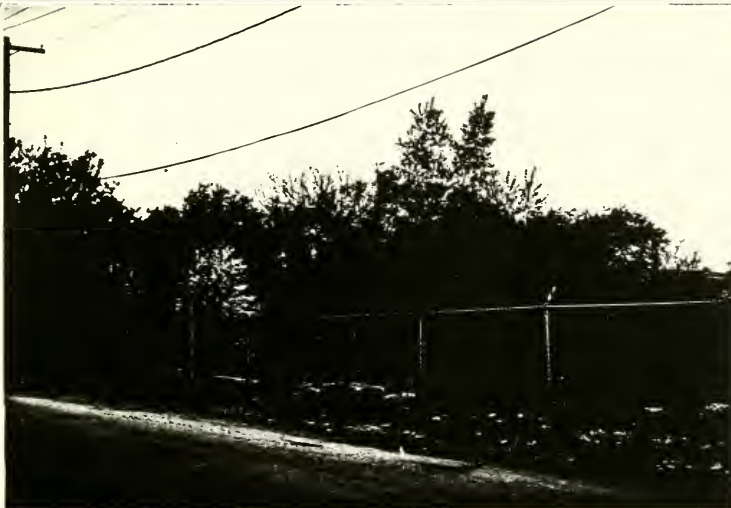
**Site Photograph 6**

View into Motherbrook II site from Reservation Road.

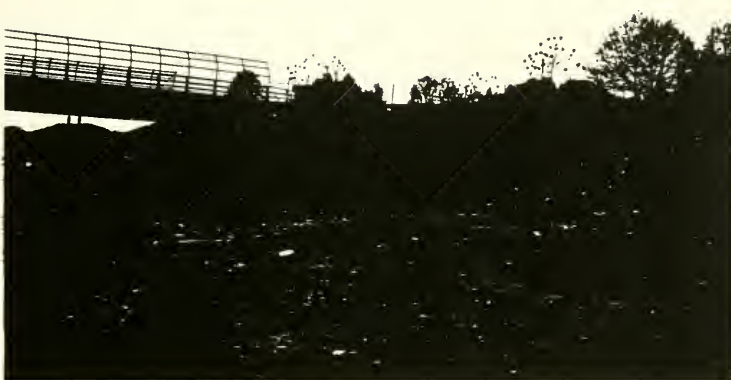
Site Photograph 8

Piles of dumped fill.

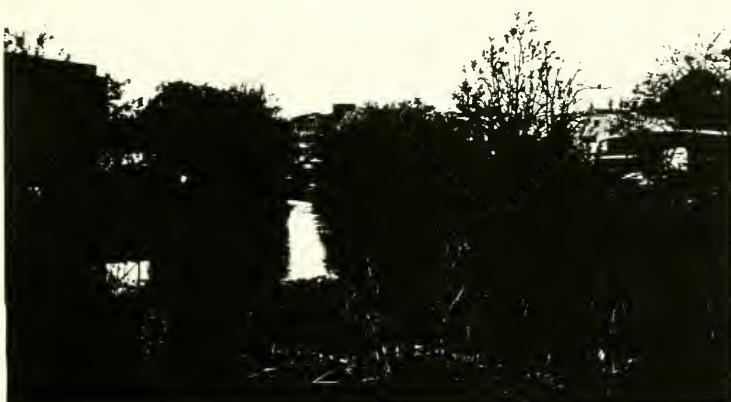
Site Photograph 9

View of Mother Brook
from Mother Brook III.

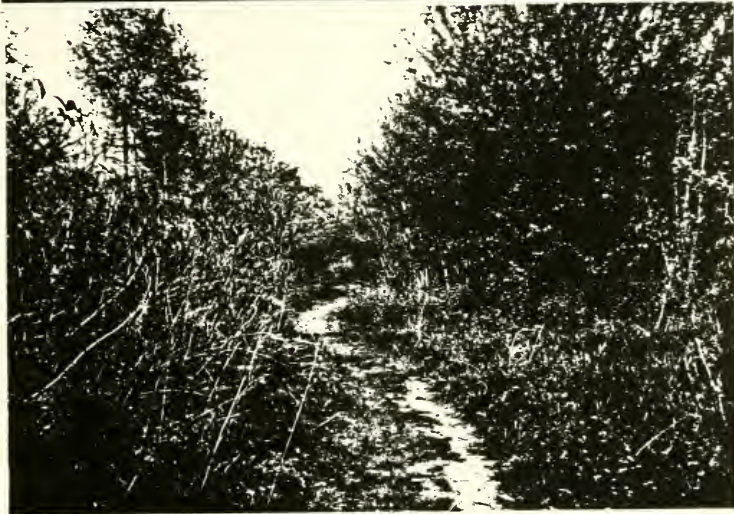
Site Photograph 2

Pathway along edge
of railway. Crabapples
thriving to right.

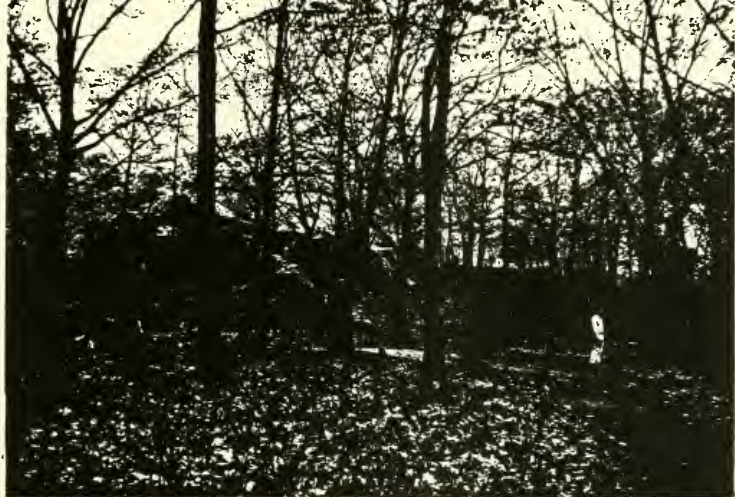
Site Photograph 4

Rock outcrop in center
of site a focal point.

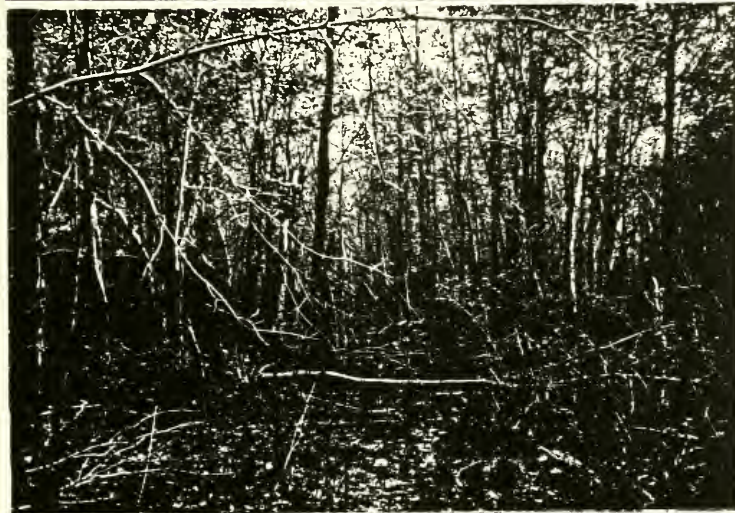
Site Photograph 5

Typical view looking
into woods.

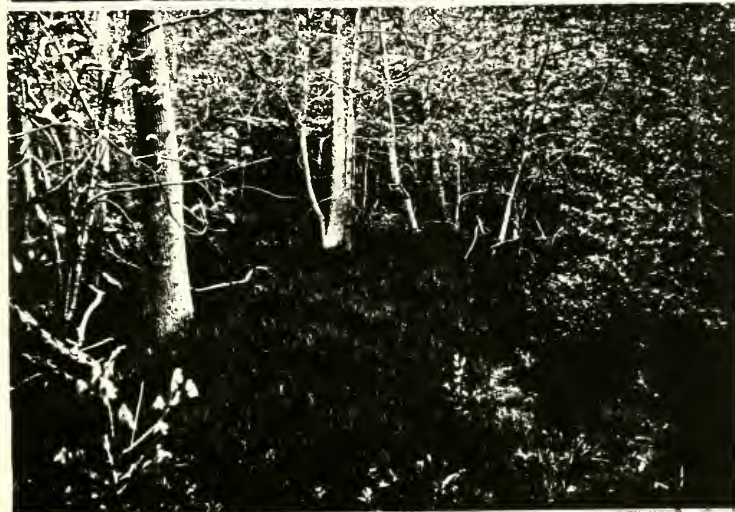
Site Photograph 6

Typical view looking
into wetland.

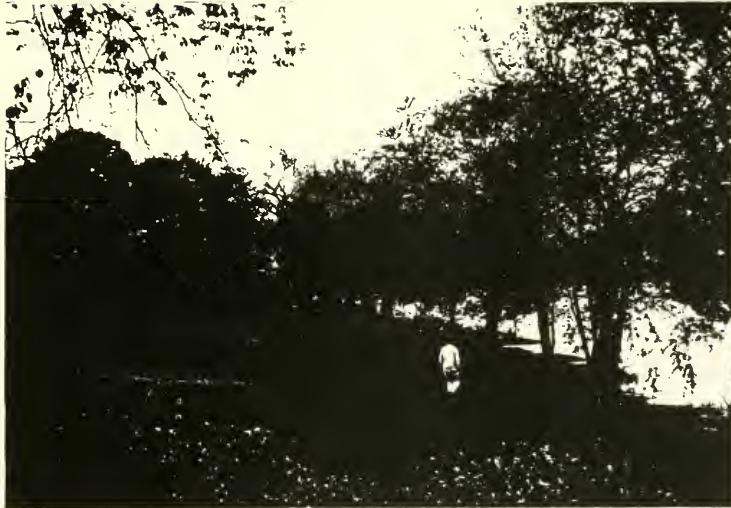
Site Photograph 1

View across site showing scenic quality of Willow trees at water's edge and well-mowed lawn.
